Date: June 09, 2006 No.: SHEA-103682

Subject: Contract DE-AC03-99SF21530 - RMHF Slope Remediation

1.0 Remediation of RMHF North Slope

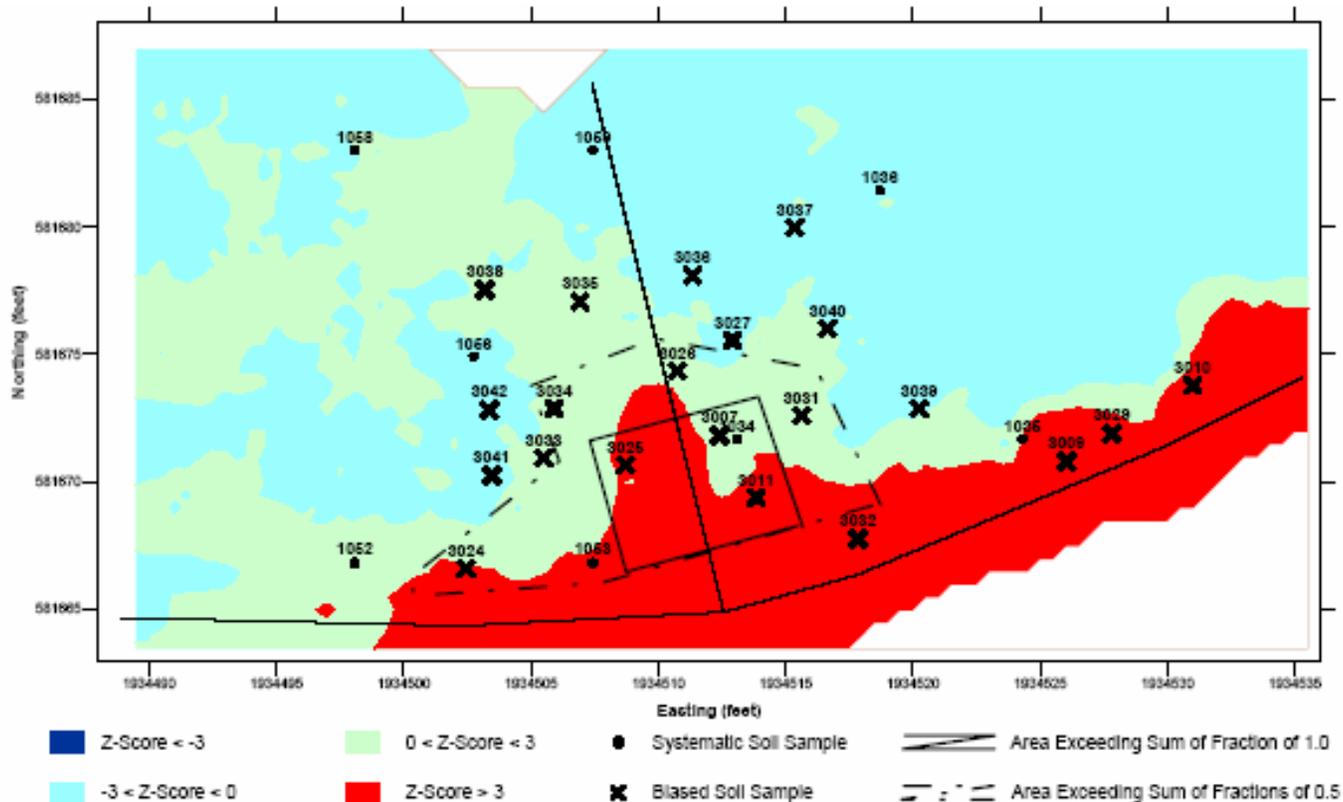
Figure 1. Contaminated Area in Survey Units 3 & 4

The referenced Final Status Survey Report of the RMHF Perimeter concluded that survey units 1, 2, 5, 6, 7, and 8 were suitable for release for unrestricted use. The report further concluded that the majority of survey units 3 & 4 was also suitable for release for unrestricted use. The report did identify one localized area overlapping the southern boundary of Survey Units 3 and 4 that had elevated cesium-137 approaching, and in several instances, exceeding the approved site-wide DCGL of 9.2 pCi/g (See Figure 1 and Table 1).

Soil samples taken within the area indicate cesium-137 ranging from non-detect to 23.5 pCi/g. See the pre-remedial data in Table 1. The DOE and DHS approved cleanup standard i.e. Derived Concentration Guidelines Level (DCGL) for cesium-137 is 9.2 pCi/g above background. Uniformly contaminated soil at this concentration (i.e. DCGL) to a depth of 1 meter would result in an annual dose to a residential

user of 15 mrem/y or an additional 5% of the U.S. average natural background dose of 300 mrem/y. Three samples detected soil that exceeded the 9.2 pCi/g DCGL. Two samples exceeded 5 pCi/g. Nine samples exceeded 2 pCi/g. The remaining fourteen samples were less than 2 pCi/g. The average soil concentration in this area was 3.6 pCi/g.

Figure 1 above shows that the area of soil exceeding the DCGL of 9.2 pCi/g is approximately 40 ft², whereas the area exceeding 5 pCi/g is approximately 100 ft².

Even with the three samples that exceed the DCGL of 9.2 pCi/g, the two survey units pass the MARSSIM recommended statistical sign test. Both survey units therefore could be released for unrestricted use with no further remediation required. However, Boeing's ALARA remediation policy requires that any soil exceeding DCGLs will be excavated.

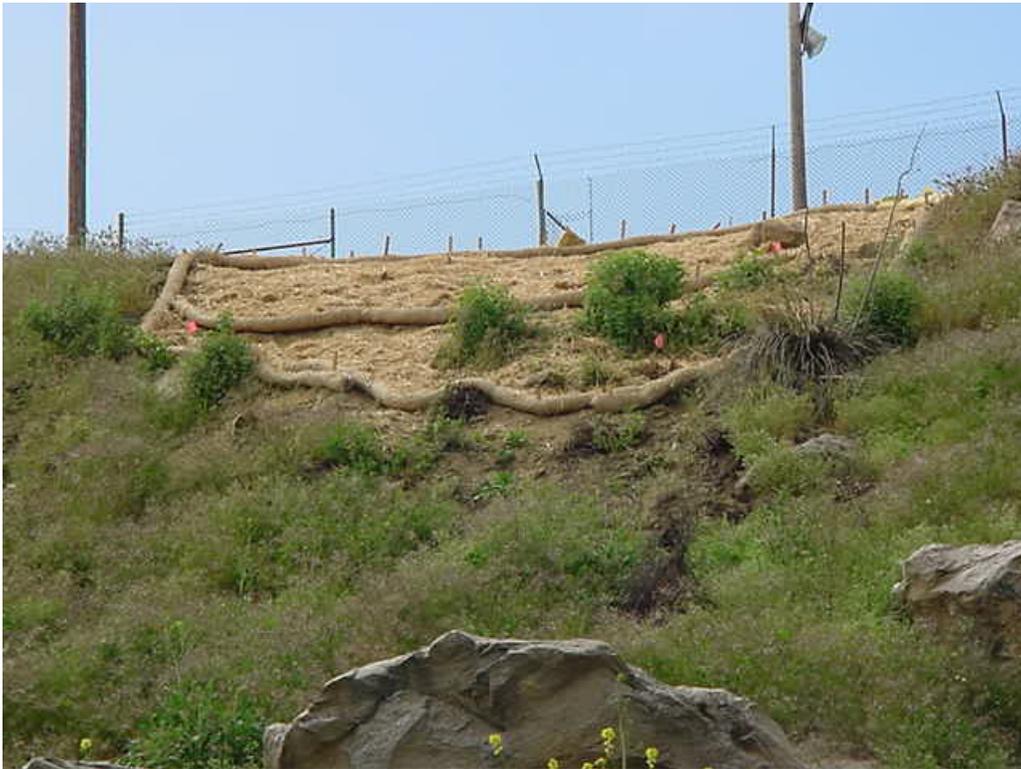
Figure 2. Remediated Area Looking from the North

Approximately 200 cubic feet of soil was removed and is pending disposal to the Nevada Test Site (NTS). Figures 2 and 3 show the extent of the remedial operations.
