# SODIUM REACTOR EXPERIMENT DECOMMISSIONING FINAL REPORT

ESG-DOE-13403
REMEDIAL ACTION AND
DECOMMISSIONING PROGRAMS

J. W. CARROLL, C. C. CONNERS,
J. M. HARRIS, J. M. MARZEC, AND
B. F. UREDA

CONTRACT: DE-AT03-76SF75008
ISSUED: 15 AUGUST 1983

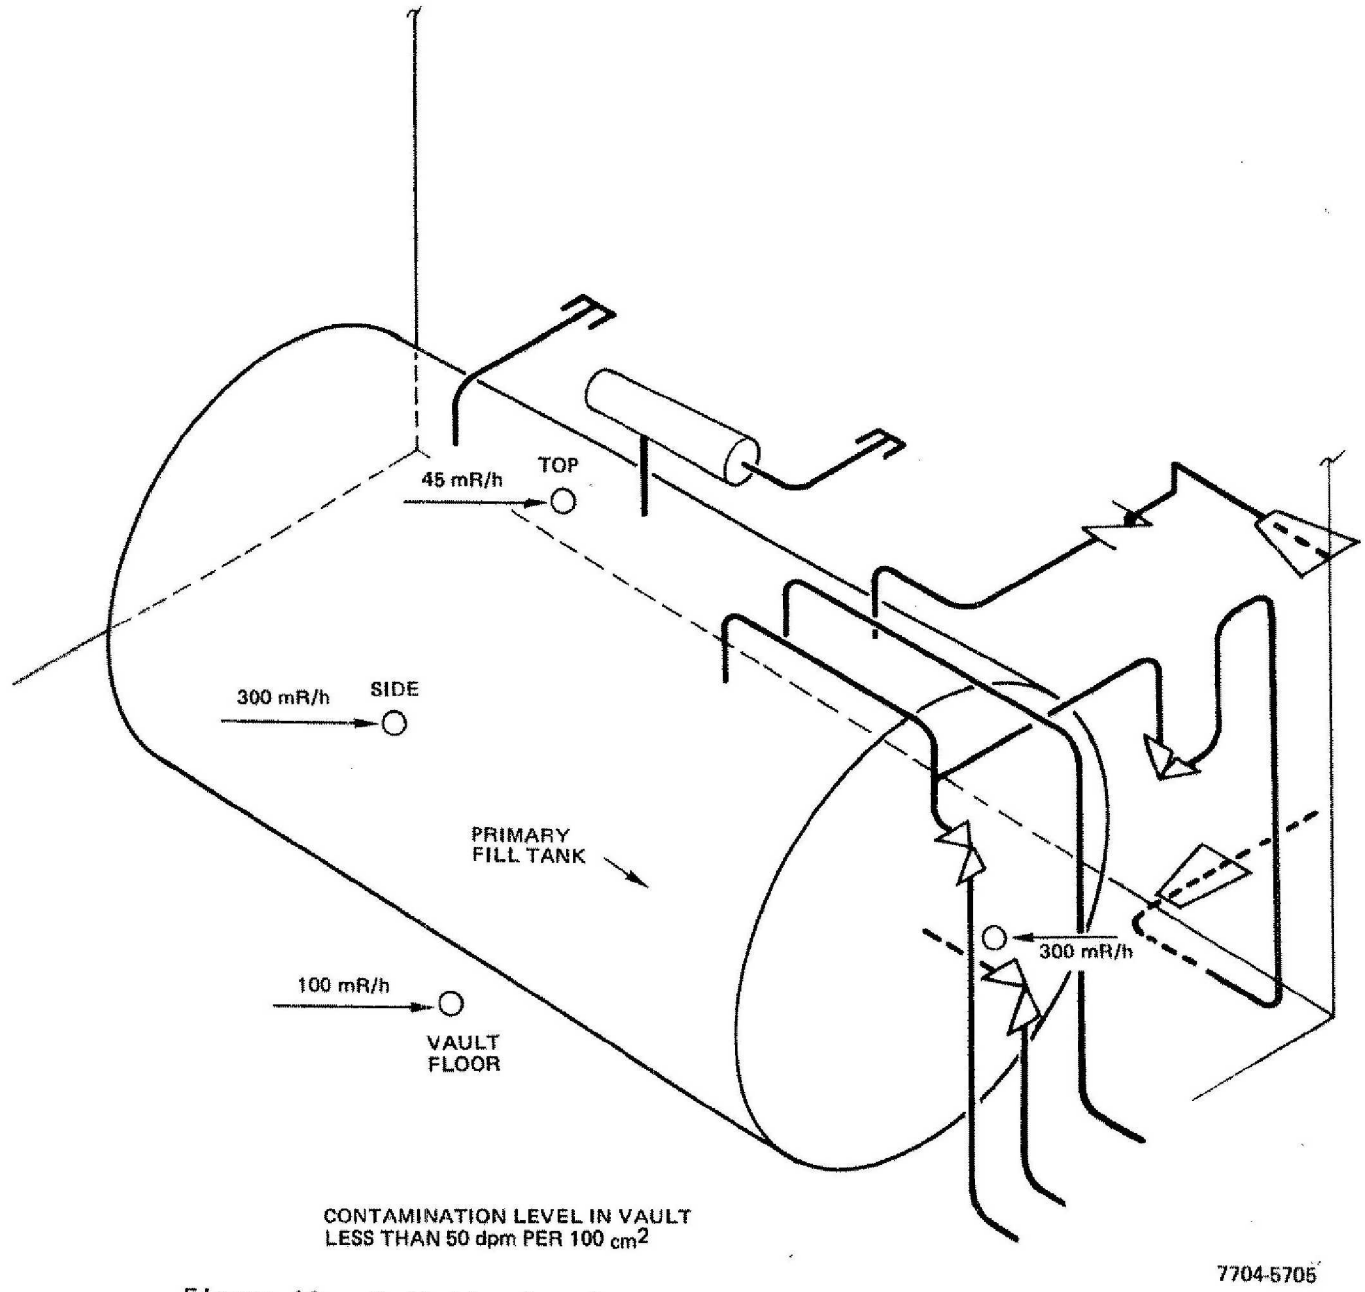
Figure 10. Radiation Levels from Tank and Associated Piping

The contamination and radiation levels present in several locations within the liquid waste system and in areas associated with this system were

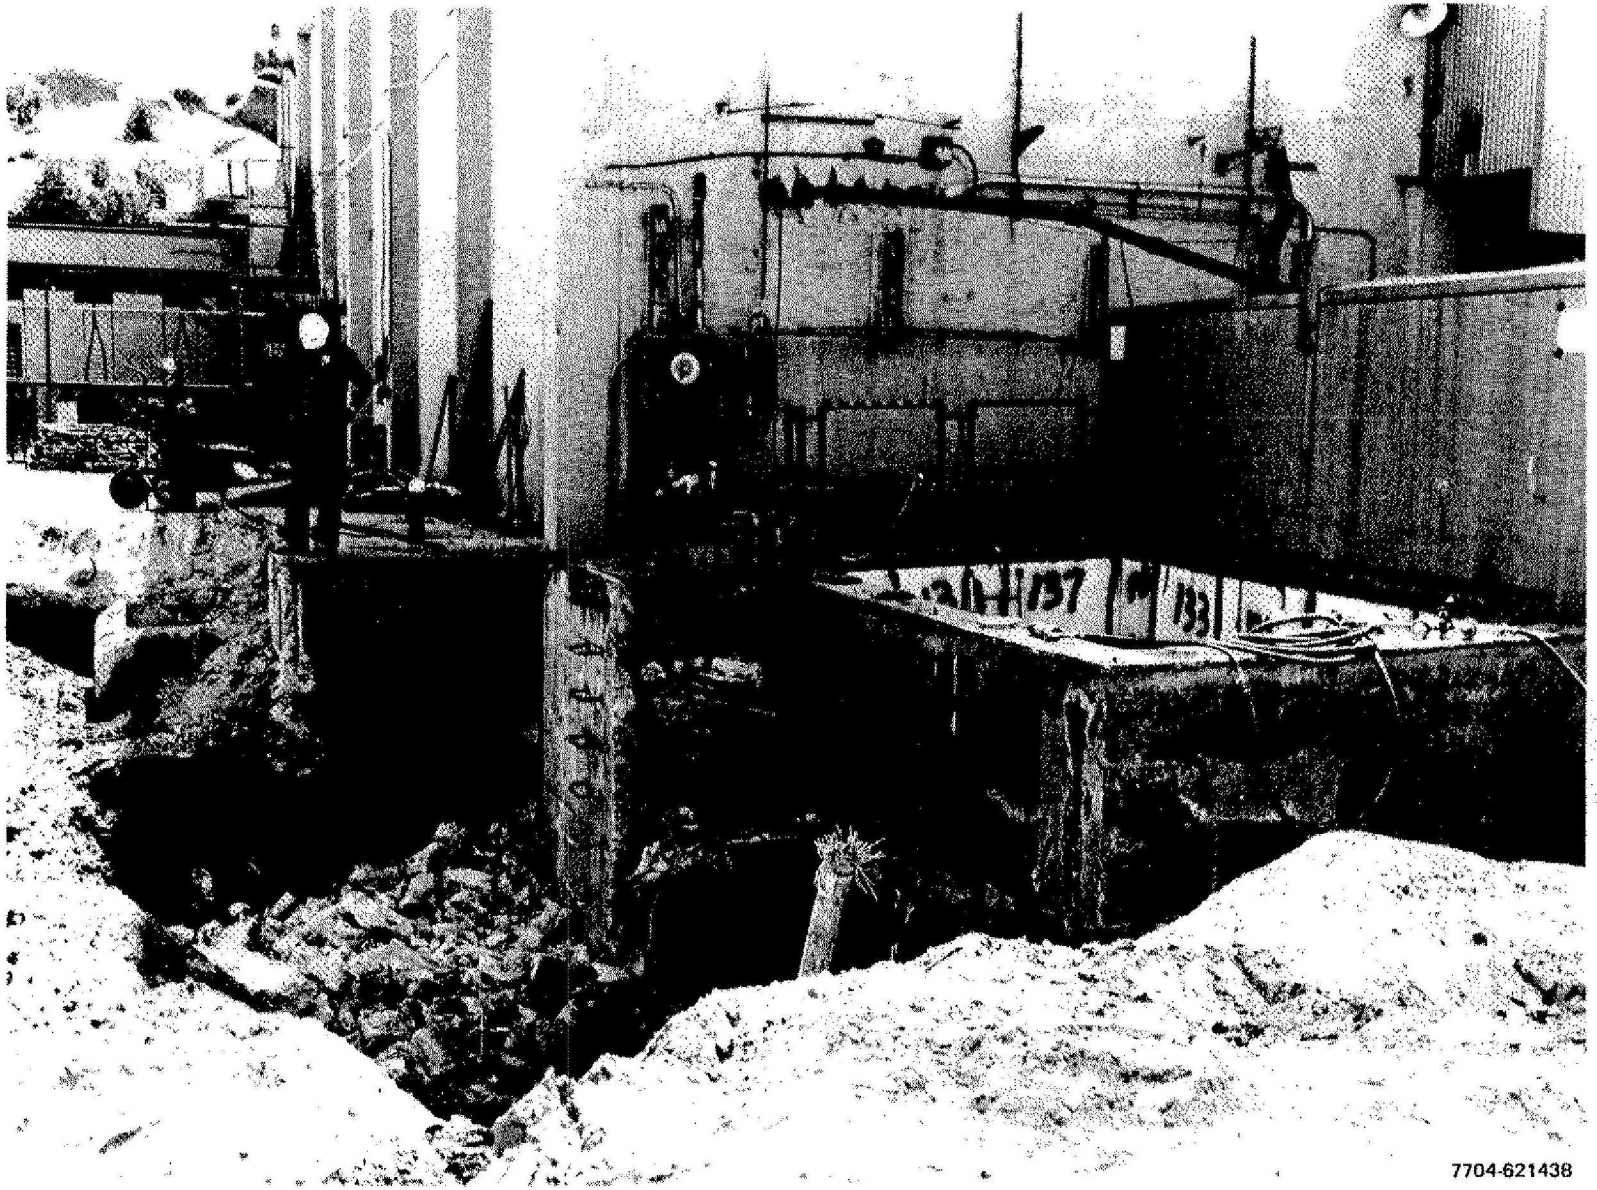
Figure 46. Initial Excavation at Northeast Corner of the SRE High Bay

Removal of contaminated soil and bedrock, particularly in the northeast corner of the reactor room, was a significant task. Contamination had penetrated below building column footings, necessitating replacement of the footings after removal of contaminated soil and bedrock.

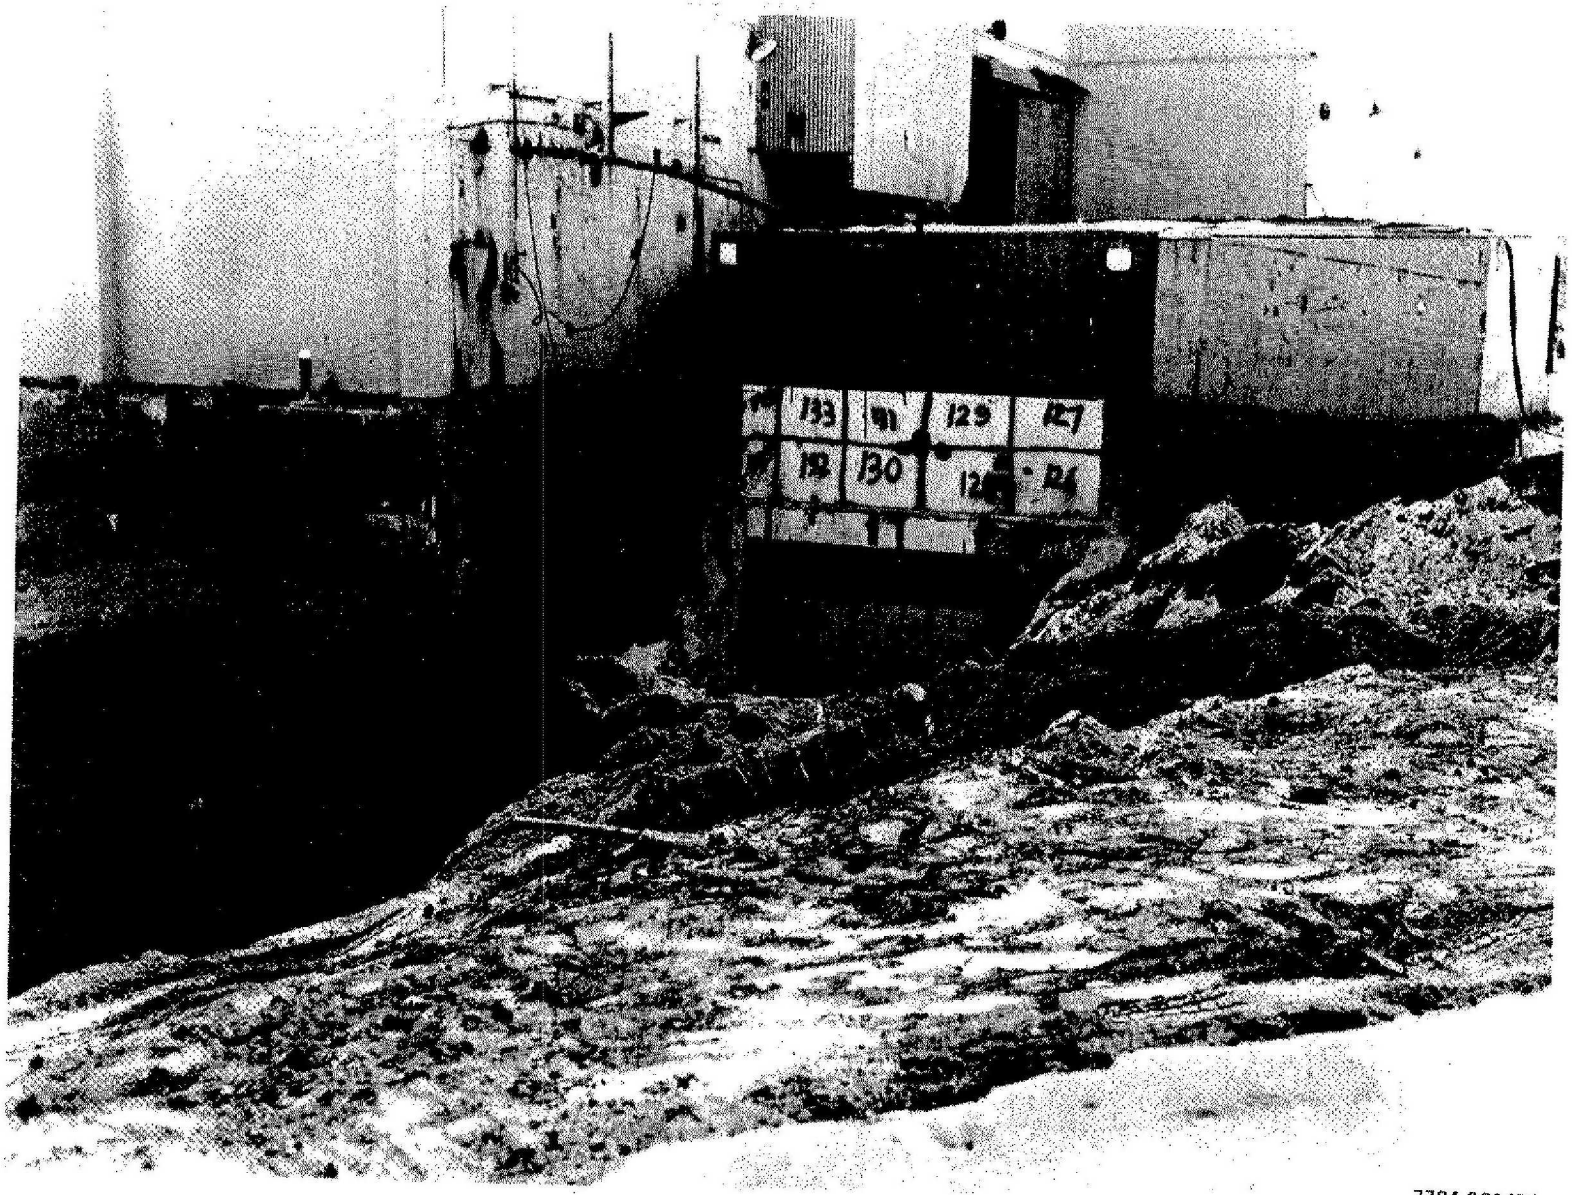
Figure 47. Excavation East of Primary Fill Tank Vault

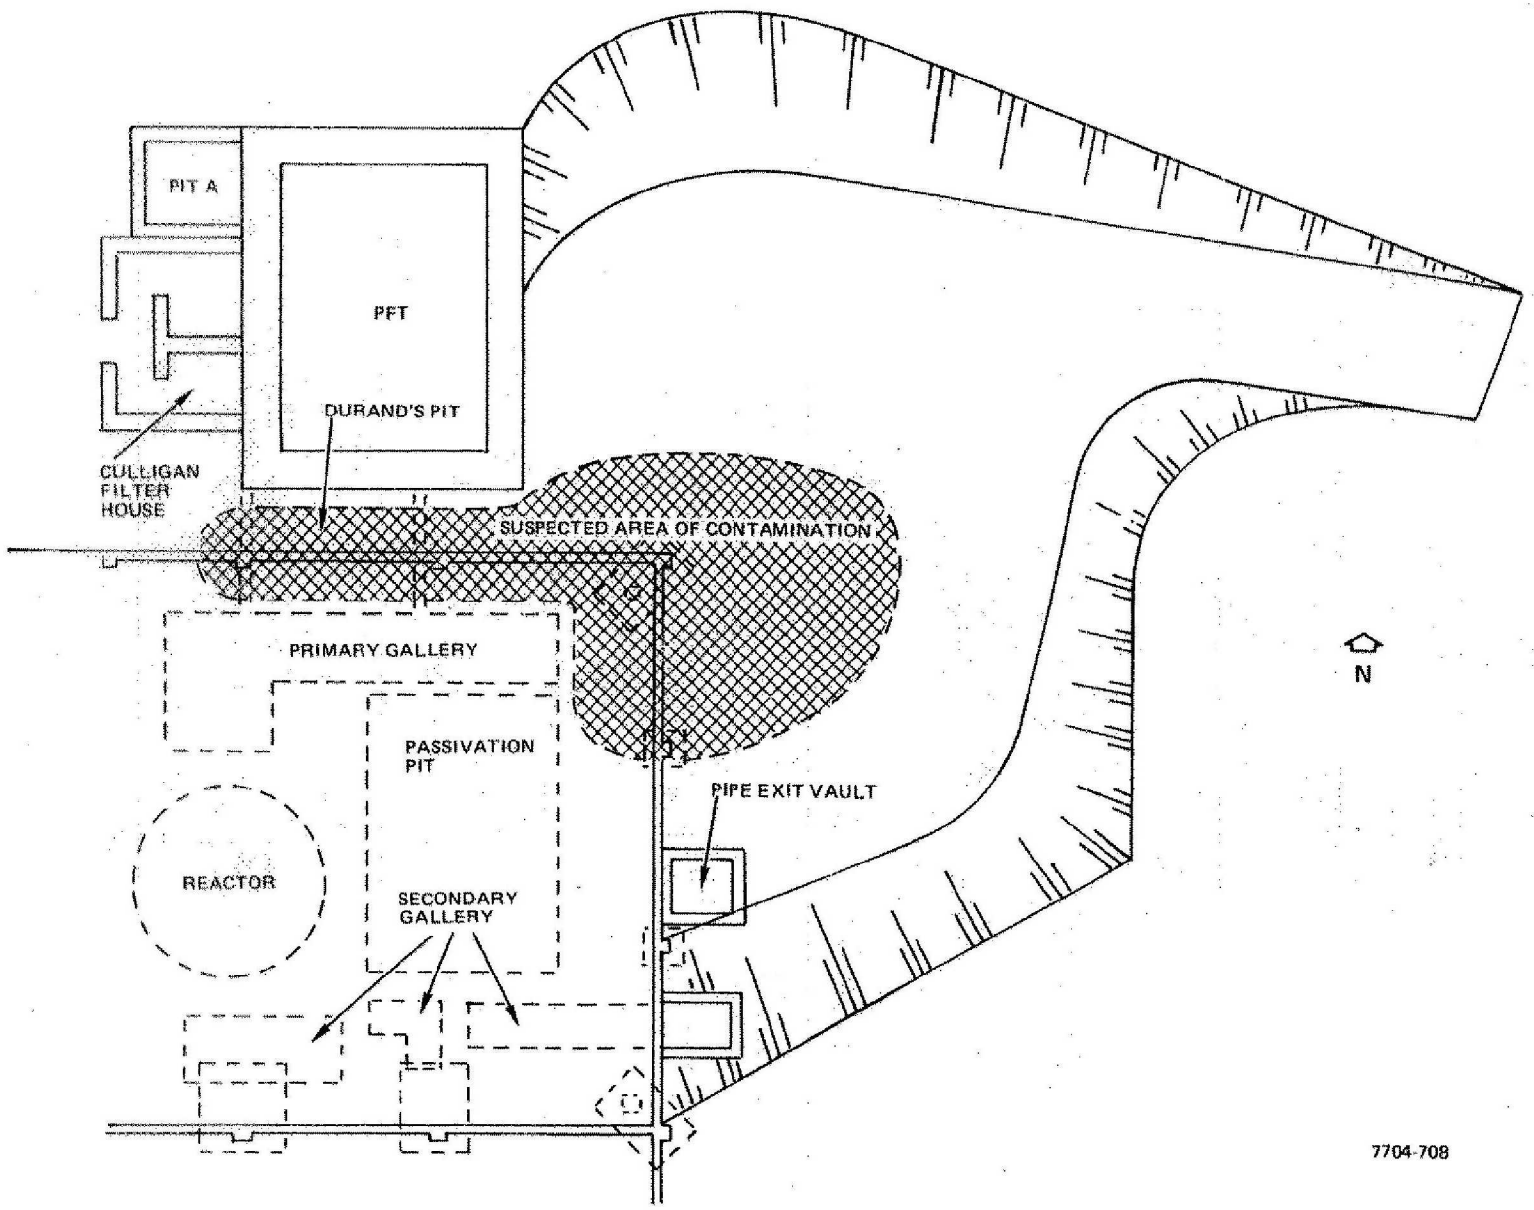
During this excavation, contamination above the Table 3 limits was found in the soil surrounding the footing at the northeast corner of the high bay. Further excavation uncovered contamination as high as 13,000 pCi/g located in cracks in the bedrock east and north of the high bay (see Figure 48). Figure 49 shows the excavation along the east face of the building. Contaminated

Figure 48. Access Ramp to High-Bay Excavation and Suspected Area of Contamination

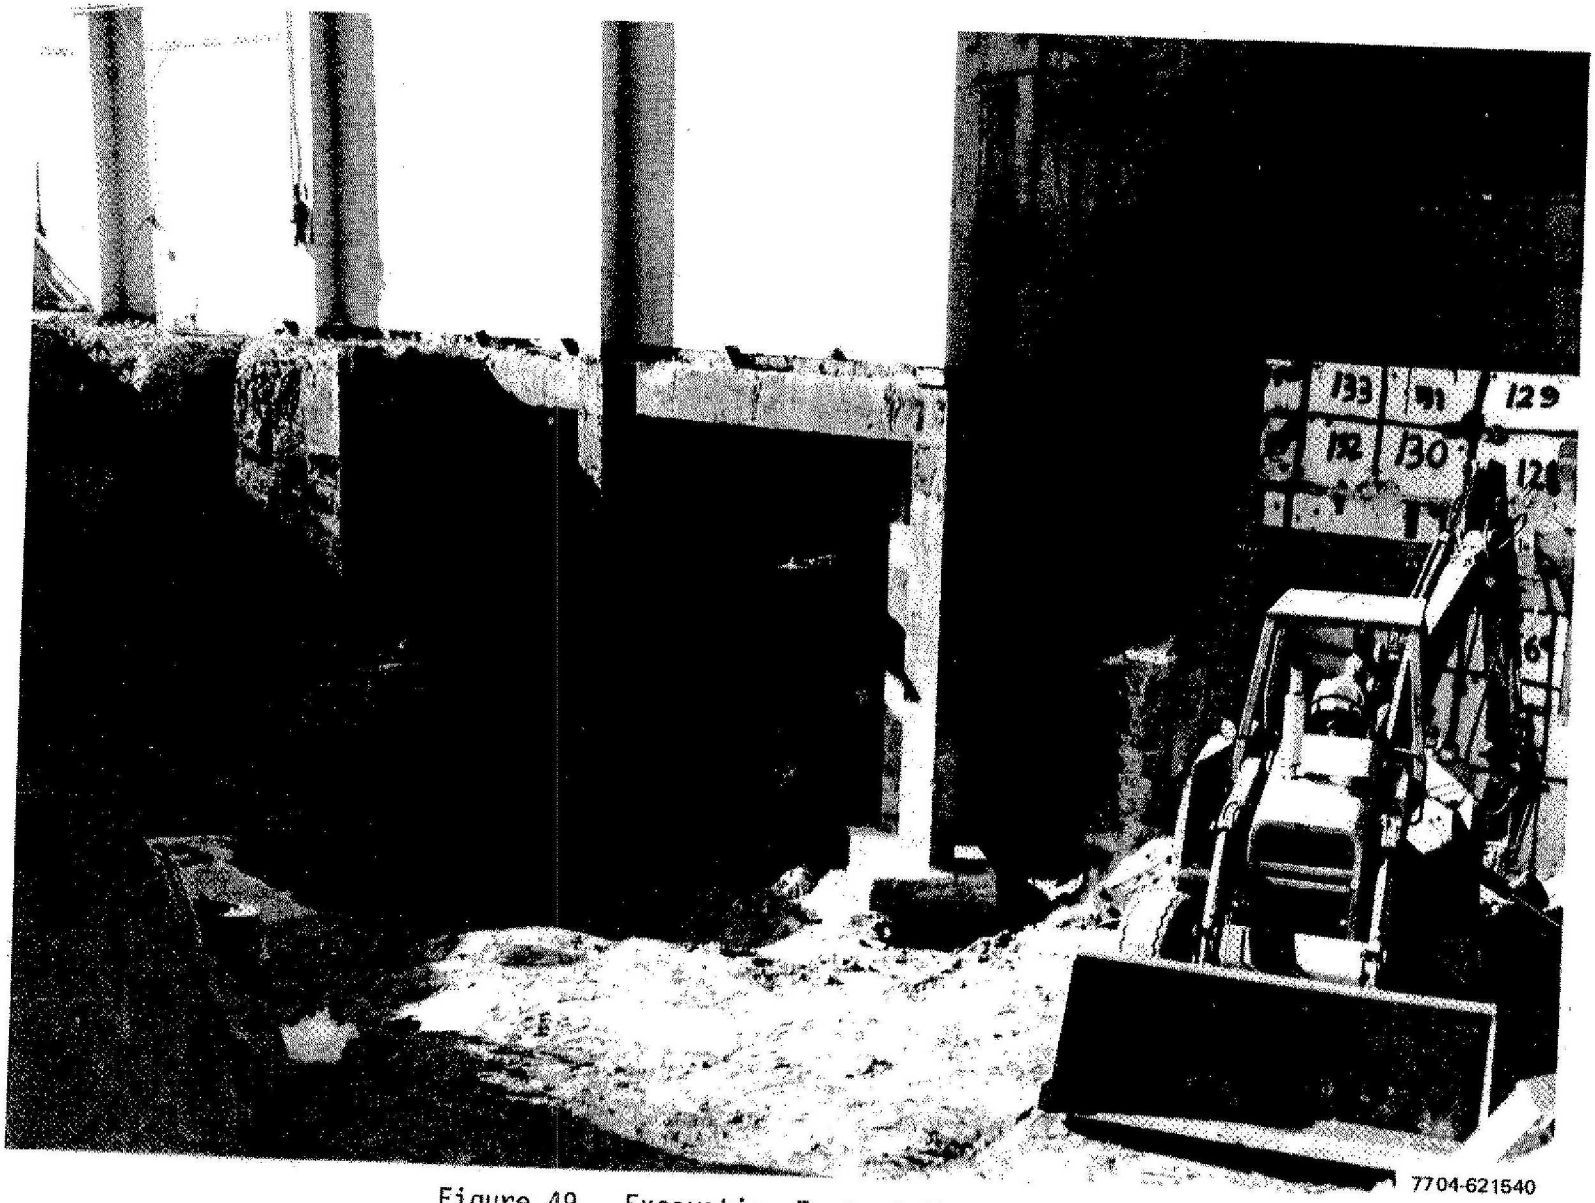
Figure 49. Excavation East of SRE High Bay

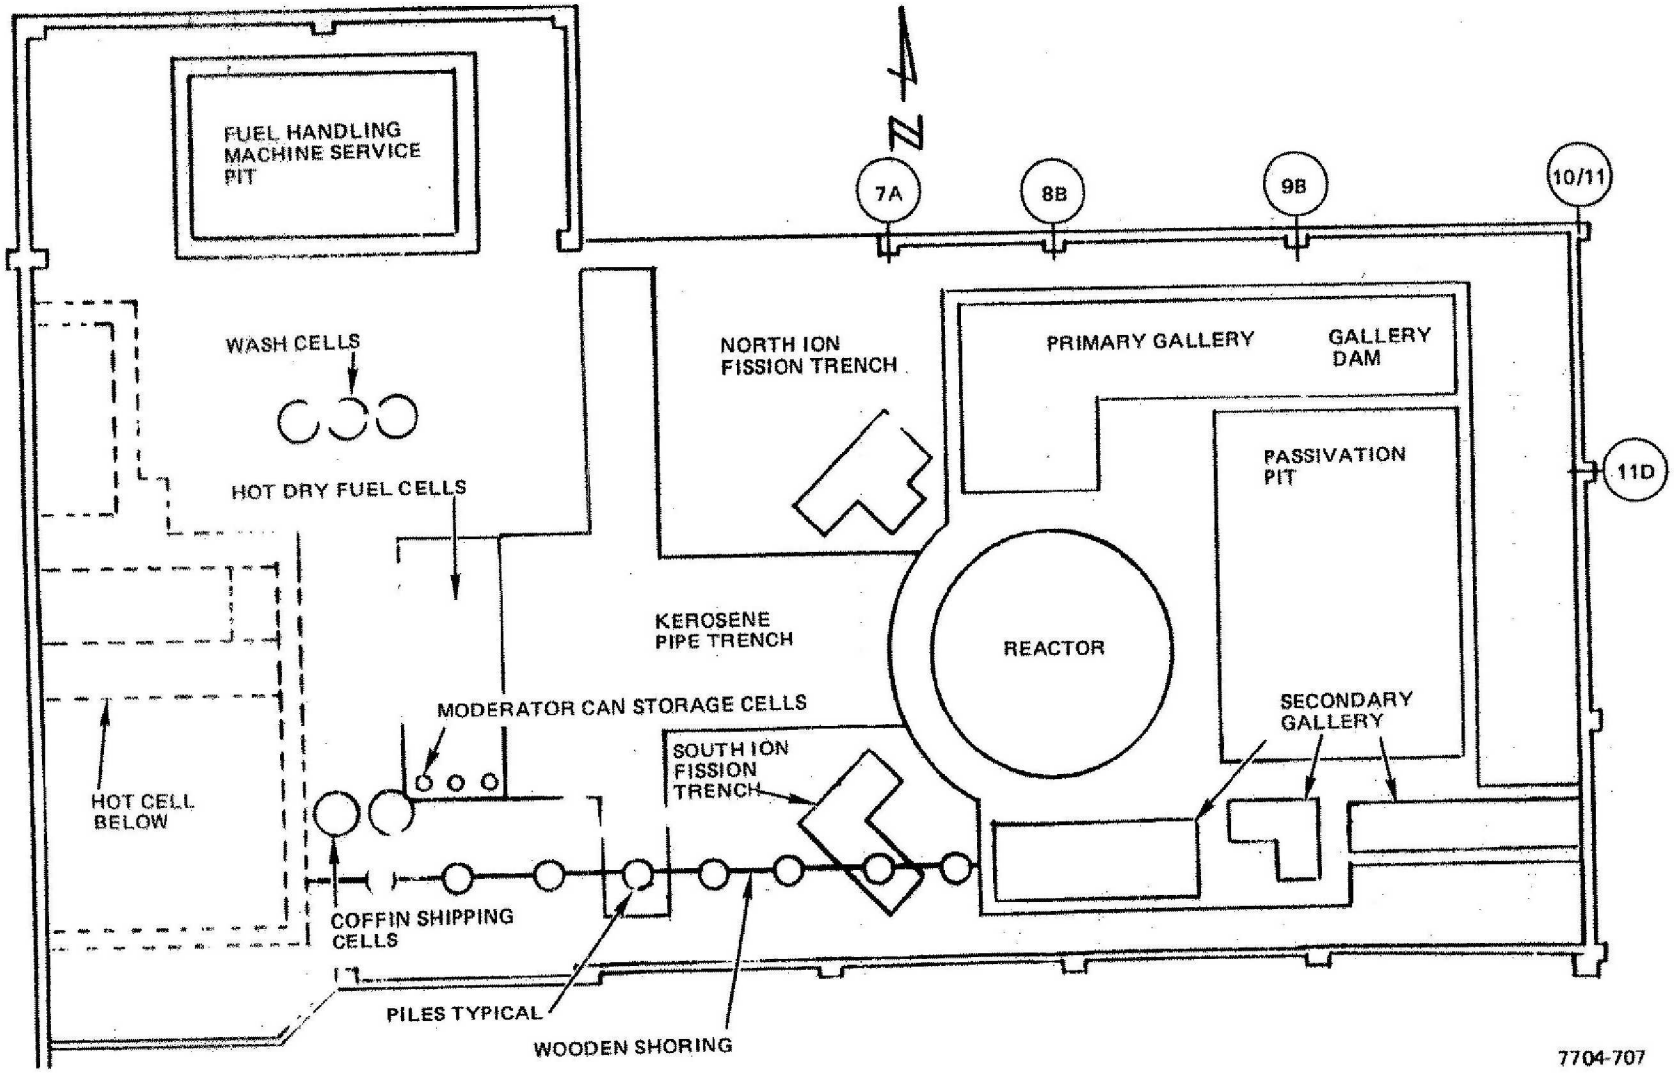
Figure 52. Location of High-Bay Retaining Wall and Column Identification

Contaminated rocks and soil were found around five facility support column footings. Three footings were along the north wall (7A, 8B, and 9B). One was along the east wall (11D). And one footing was at the corner where the north and east walls meet (10/11) (see Figure 52). The structural consultant previously contacted was again brought in on contract. A series of temporary footings, cross bracing, and support columns needed to be installed if excavations were required near or below these five column footings. Exploratory excavations in this area were performed using jackhammers and hand tools. Rock and soil samples were analyzed, and the results were compared with previous samples. Extrapolation was used to estimate the depth of radioactive contamination in several visible cracks. Based on this information, it was apparent that the only solution was to remove the contaminated soil from beneath the footings.

The level chosen for a specific column footing was based on the extrapolated amount of contamination expected. One column was partially undermined (10/11). Two columns were totally undermined (7A and 11D). And two columns and footings were removed and later replaced (8B and 9B). The installation of temporary footings and columns was subcontracted. Only one column was worked on at a time, and a full, 28-day cure was permitted on a foundation or column before work was started on an adjacent footing. Figure 54 shows the column supports and the seismic braces anchored to the floor of the primary fill tank vault. Figure 55 shows the column bracing inside the high bay. Column 7A, on the left, already has a new foundation and reinforced footing in place. Note that Column 9B has been removed.

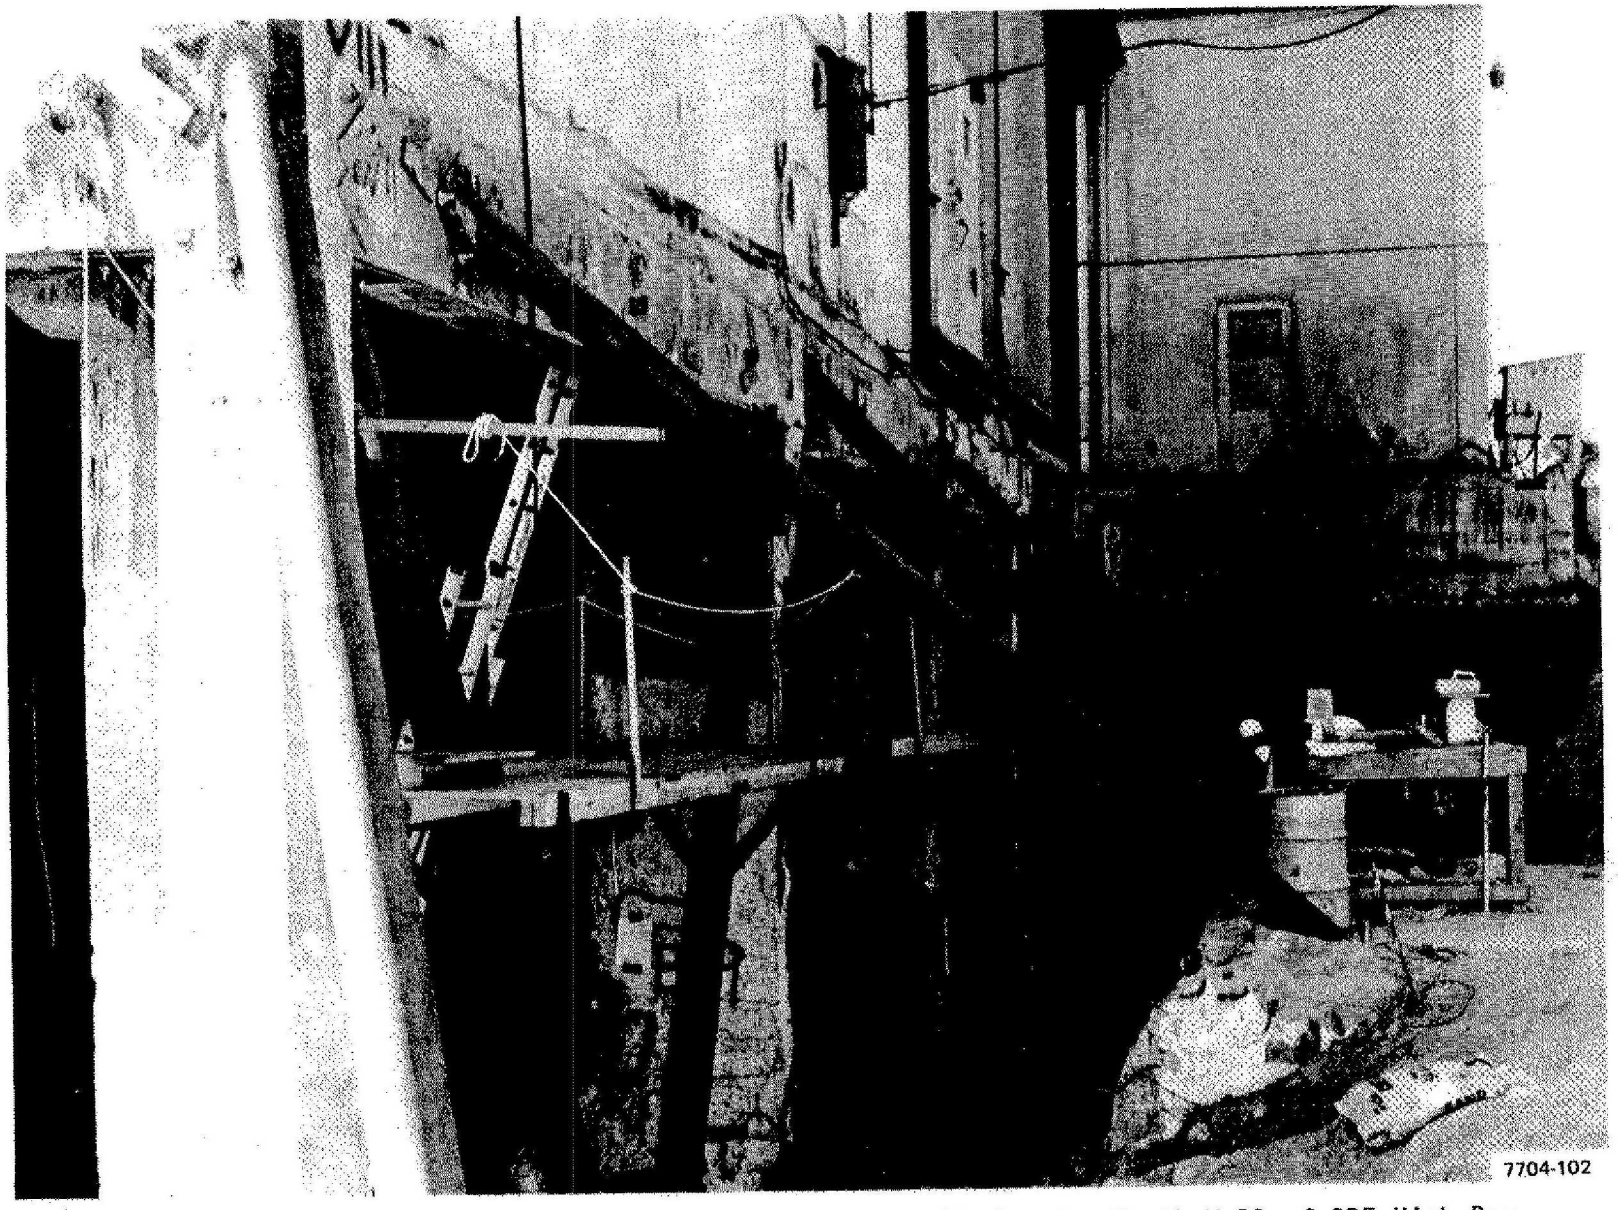
Figure 54. Column Supports and Seismic Bracing Installed under North Wall of SRE High Bay

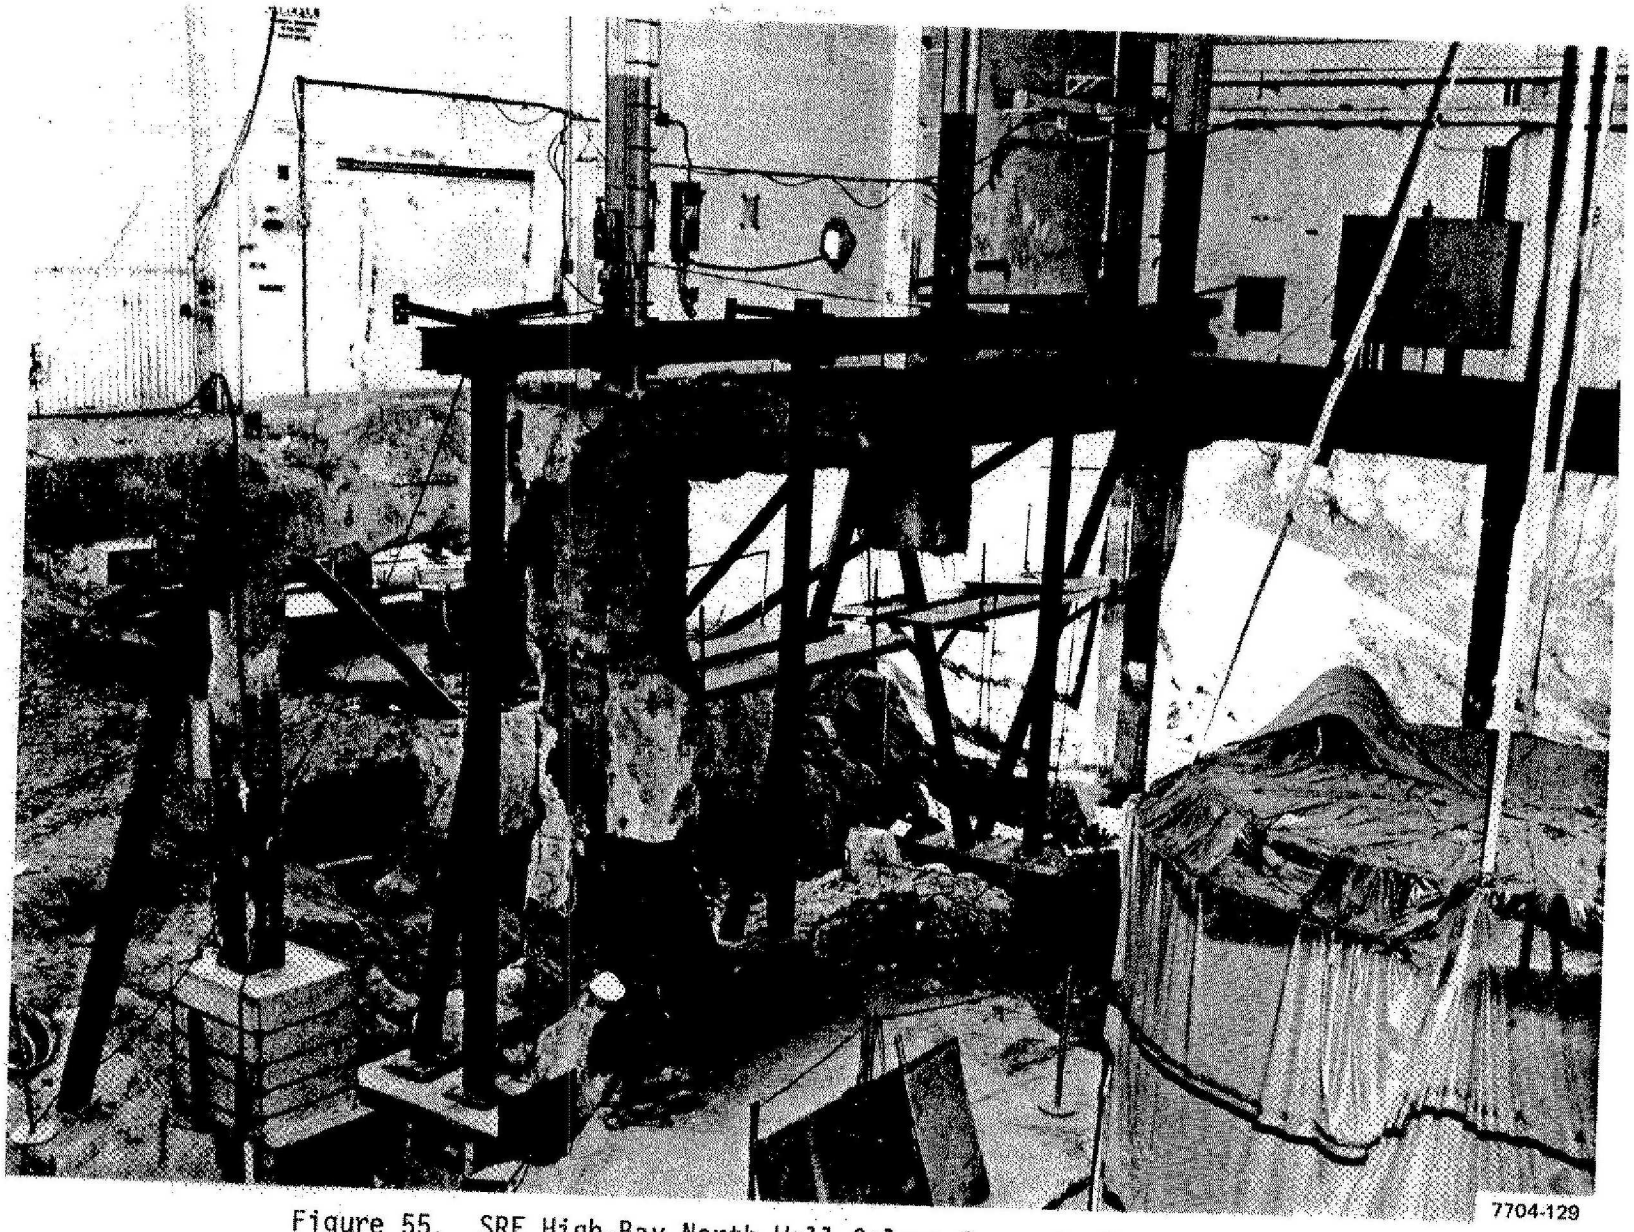
Figure 55. SRE High-Bay North Wall Column Supports Interior View

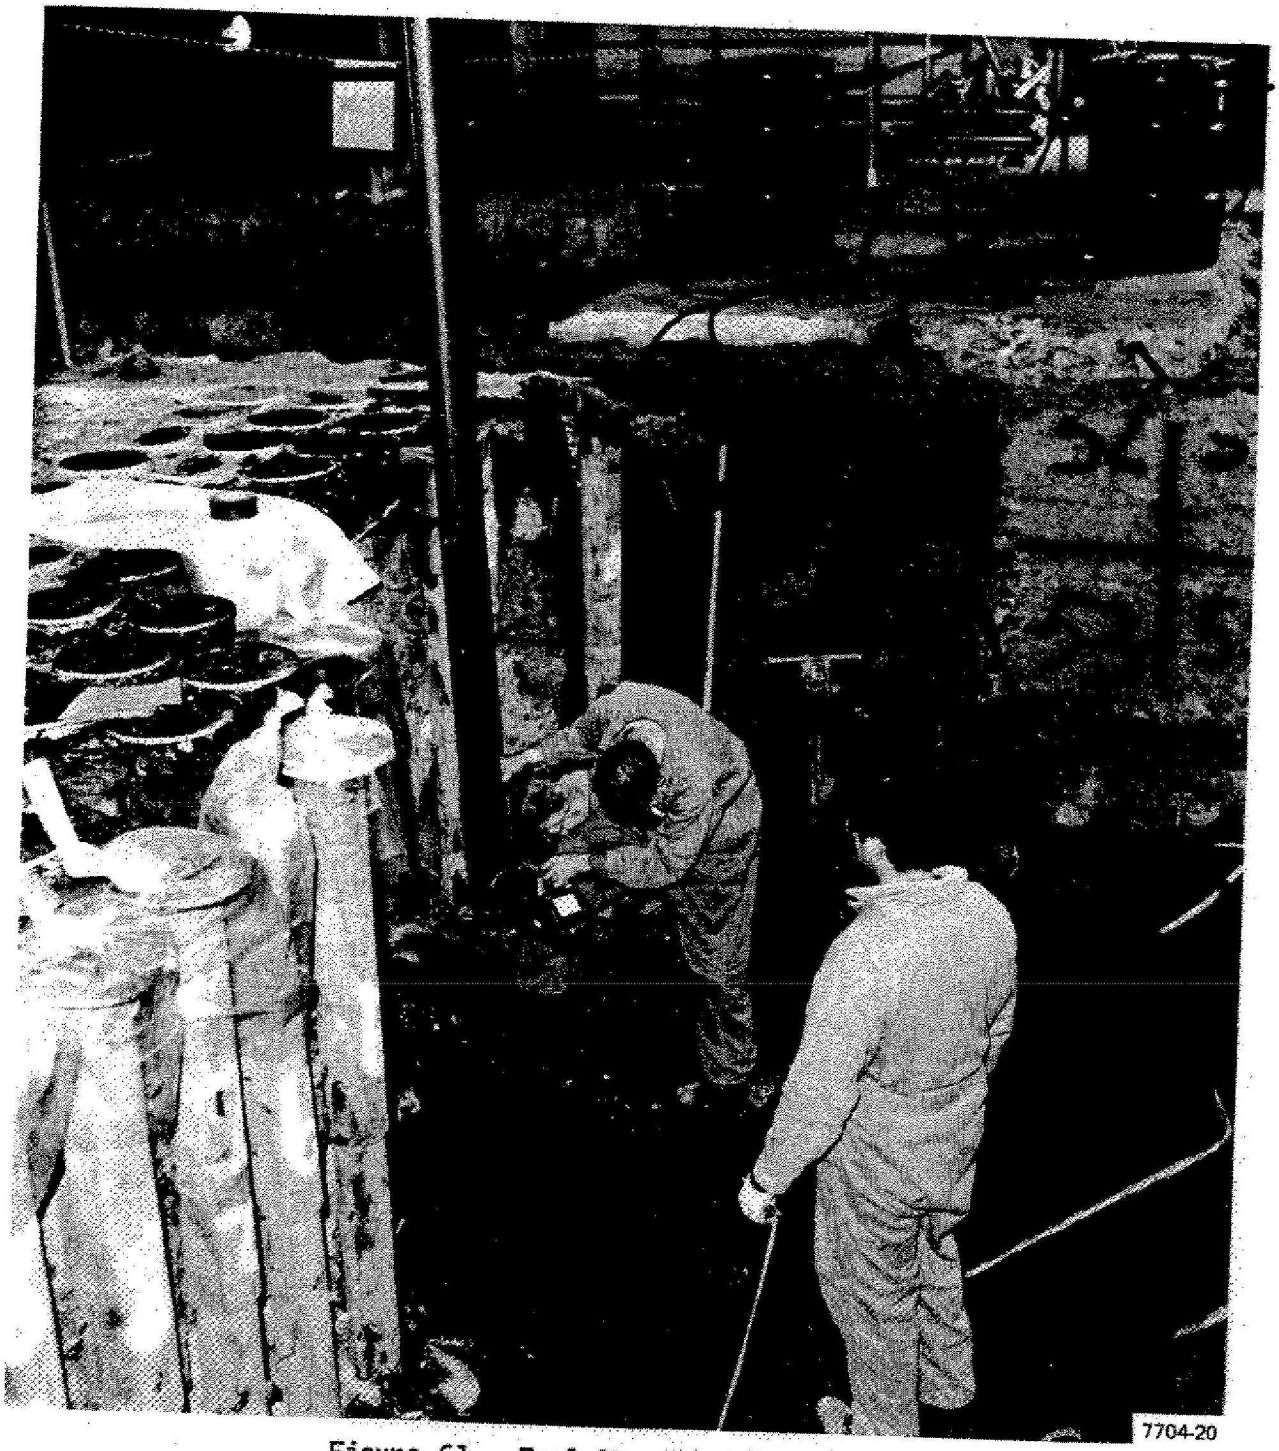
cells. The high-pressure, low-volume water spray was used to control dust. Figure 61 shows a health physicist surveying a fuel storage tube as it is removed. The kerosene cooling line can be seen along the side and looping around the bottom of the tube. Figure 62 shows the demolition of the remaining fuel storage cell concrete structure after the tubes were removed. One tube can be seen next to the moderator element storage cells. Note the detail of the retaining wall construction.

Figure 61. Fuel Storage Tube Removal

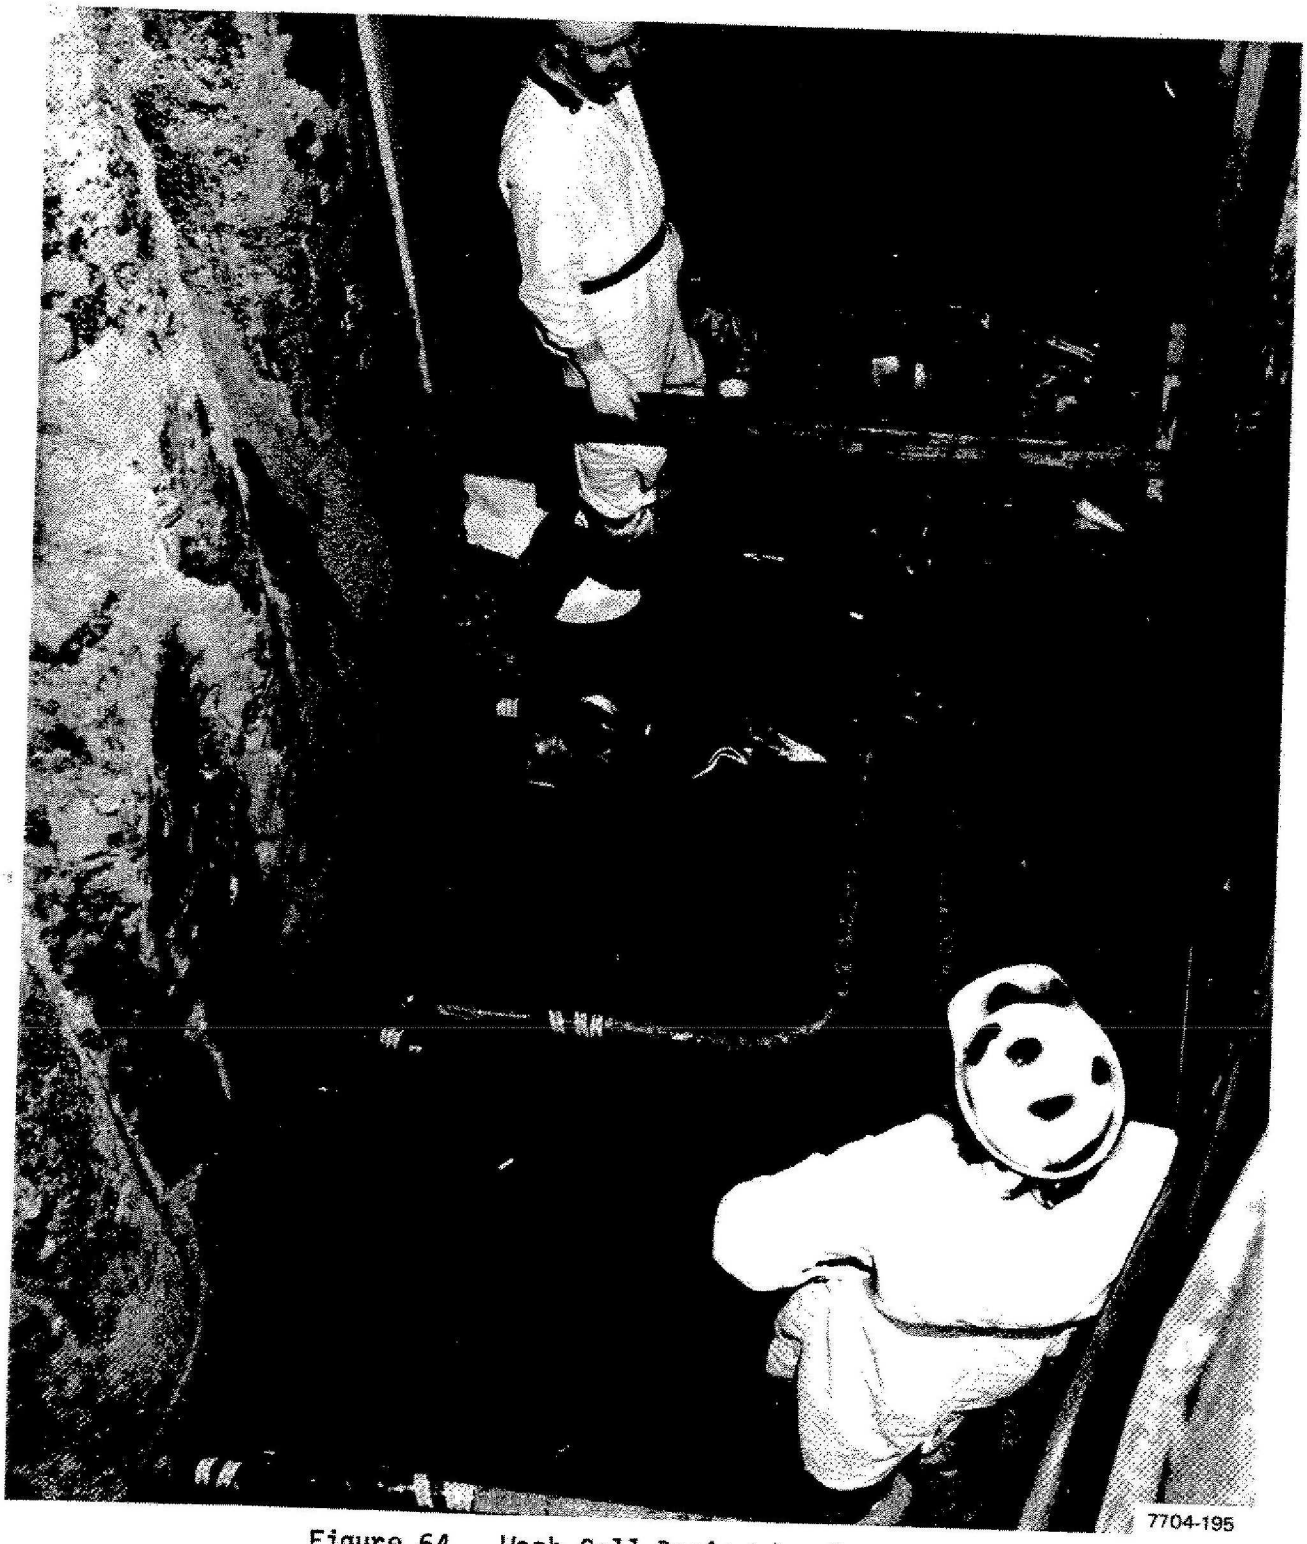
Figure 64. Wash Cell Drain Line Removal

to remove the drain pipes. The upper right corner of Figure 62 shows a portion of the shoring installed for the wash cell drain line removal.

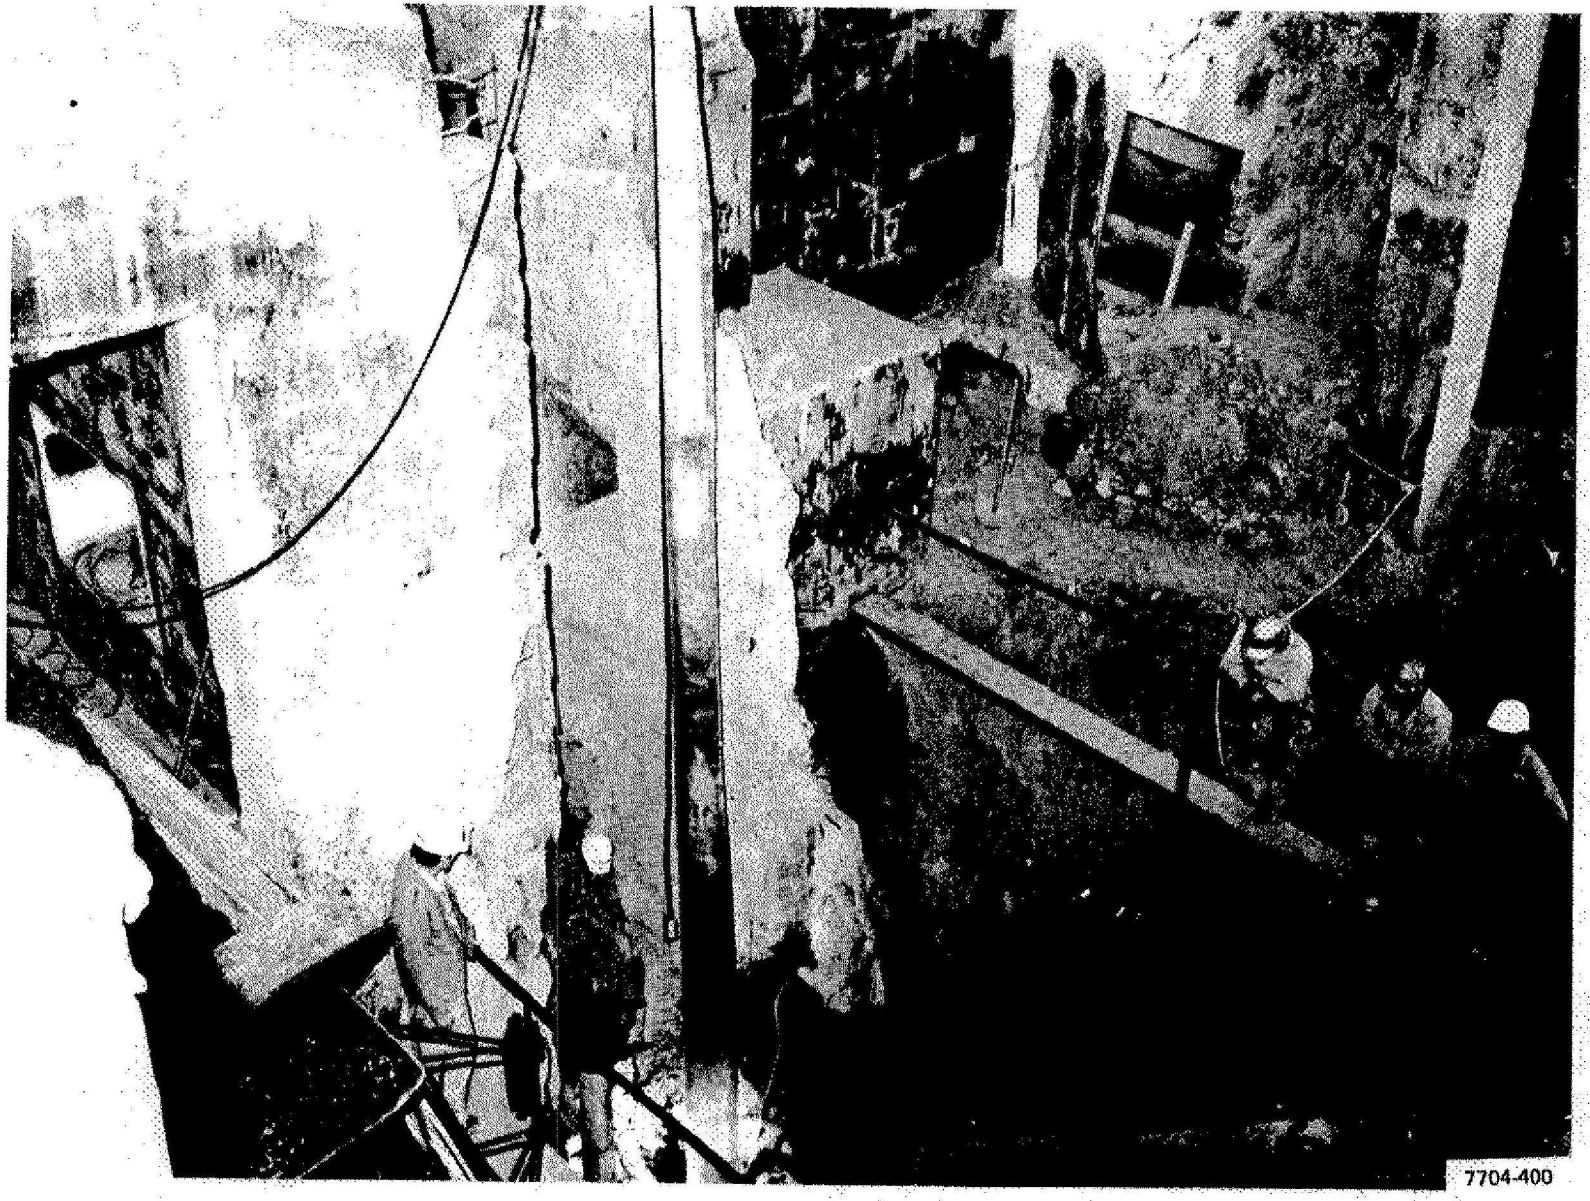
When the sleeves were uncapped, they were found to contain 2 to 4 ft of water. Analysis of samples indicated levels above the maximum permissible concentration for mixed fission products. The small side diameter of the sleeves made decontamination of the interior surface virtually impossible. It was decided to remove the sleeves. The Hy-Ram was used to expose the top section of the two units. It quickly became apparent that the small backhoe/Hy-Ram combination would not be capable of excavating a hole deep enough to reach the bottom of the sleeves. The preliminary excavation also showed that the two units were most likely encased in concrete for their entire length.

Figure 68. Fuel Element Enclosure Sleeve Removal

1) A low-strength concrete mix was placed in the excavation dug by the small backhoe. This provided a smooth, solid surface for a rock drill, adjacent to the sleeves.
2) A rock drill was used to drill a pattern of 93 holes in approximately a 10-ft by 10-ft area. The holes were a minimum of 30 ft deep.
3) A large backhoe capable of excavating 35 ft straight down was brought onsite. The large backhoe was also equipped with a Hy-Ram to fracture the bedrock which had been weakened by the rock drilling.
4) The two sleeves were pumped dry and then filled with an expanding polyurethane foam to fix contamination. If the Hy-Ram or backhoe had inadvertently punctured a sleeve, the foam would have minimized the spread of contamination.

Figure 66 shows the rock drill in operation. Figure 67 shows the large backhoe in operation inside the high-bay excavation. Figure 68 shows one of the two sleeves being removed from the excavation.
