# SODIUM REACTOR EXPERIMENT DECOMMISSIONING FINAL REPORT

ESG-DOE-13403
REMEDIAL ACTION AND
DECOMMISSIONING PROGRAMS

J. W. CARROLL, C. C. CONNERS,
J. M. HARRIS, J. M. MARZEC, AND
B. F. UREDA

CONTRACT: DE-AT03-76SF75008
ISSUED: 15 AUGUST 1983

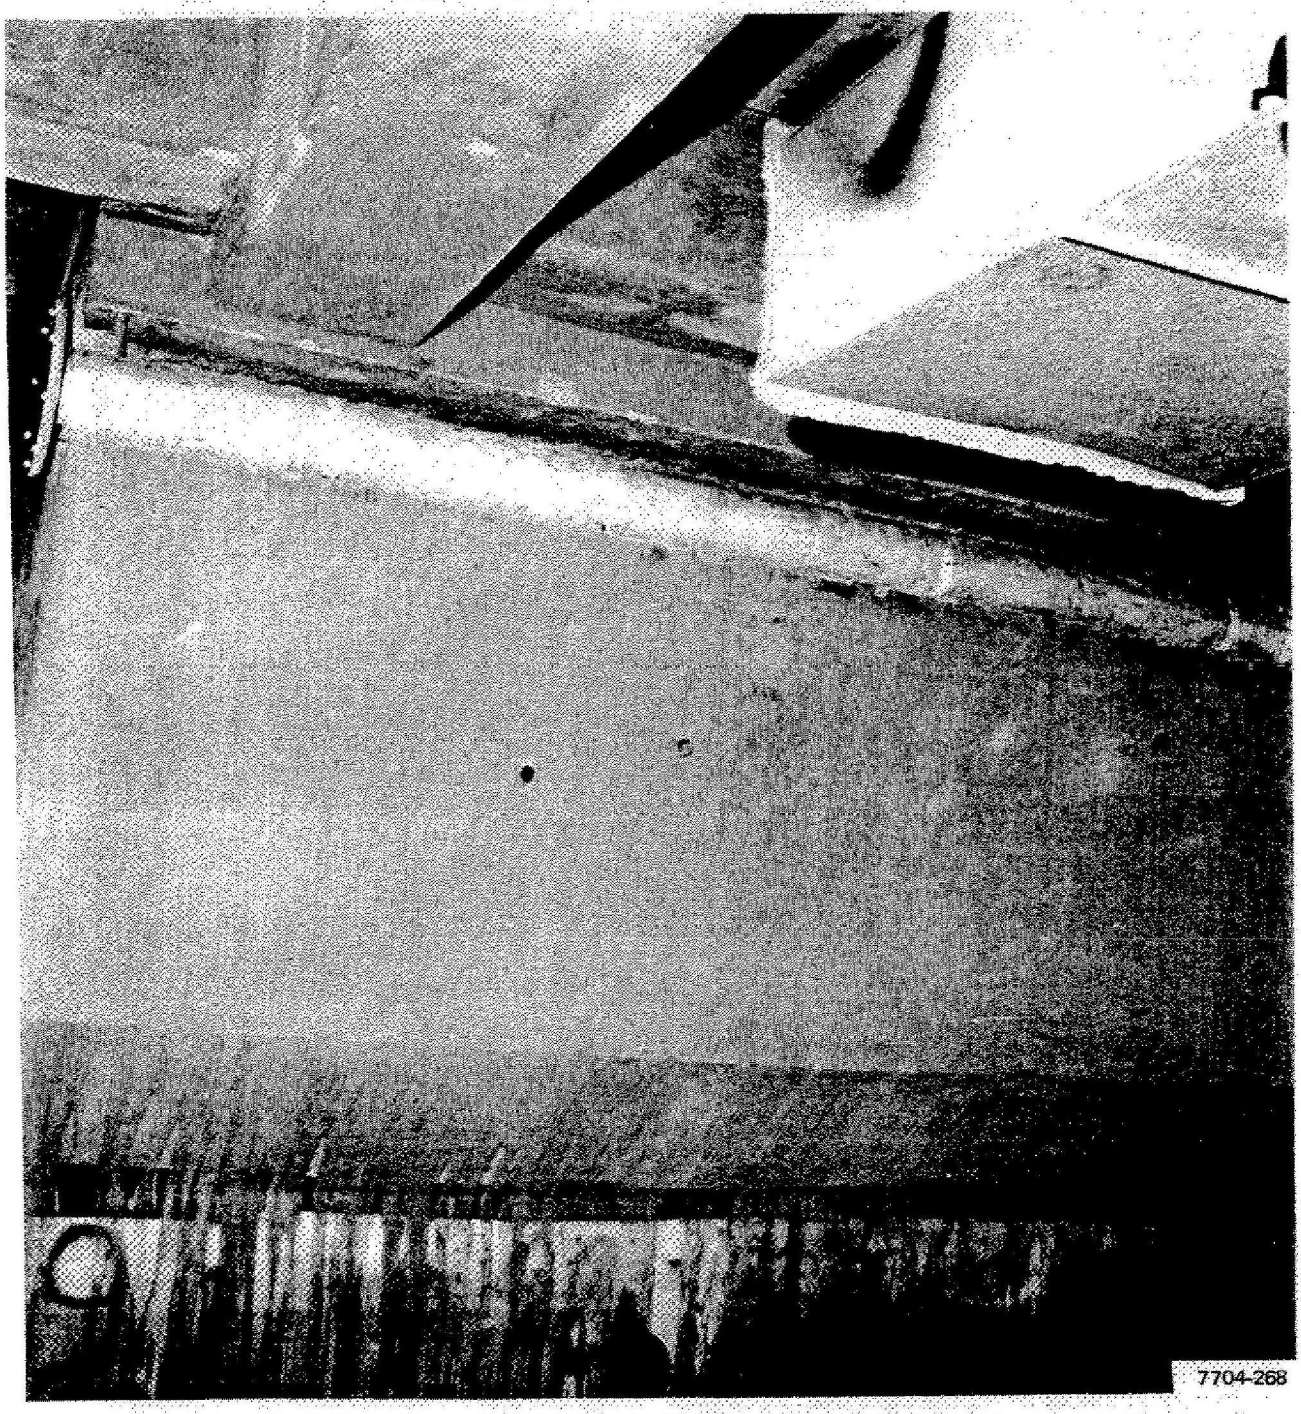
The in-cell floor drains and the hot cell air exhaust line were removed. The exhaust line was an 8-in.-diameter, thin wall tube used to discharge the primary cell atmosphere to the above-grade radioactive exhaust system. The tubing was embedded in the concrete wall between the primary hot cell and the hot cell operating gallery, inches away from the grade beam supporting the west wall of the high bay. A method was found to remove the tubing without endangering the structural integrity of the building. A combination of concrete sawcutting and jackhammering by hand was successful. The exhaust line was removed intact without damage to the facility. Figure 72 shows the primary cell wall and the exposed exhaust line.

Figure 72. Exposed Primary Hot Cell Exhaust Line

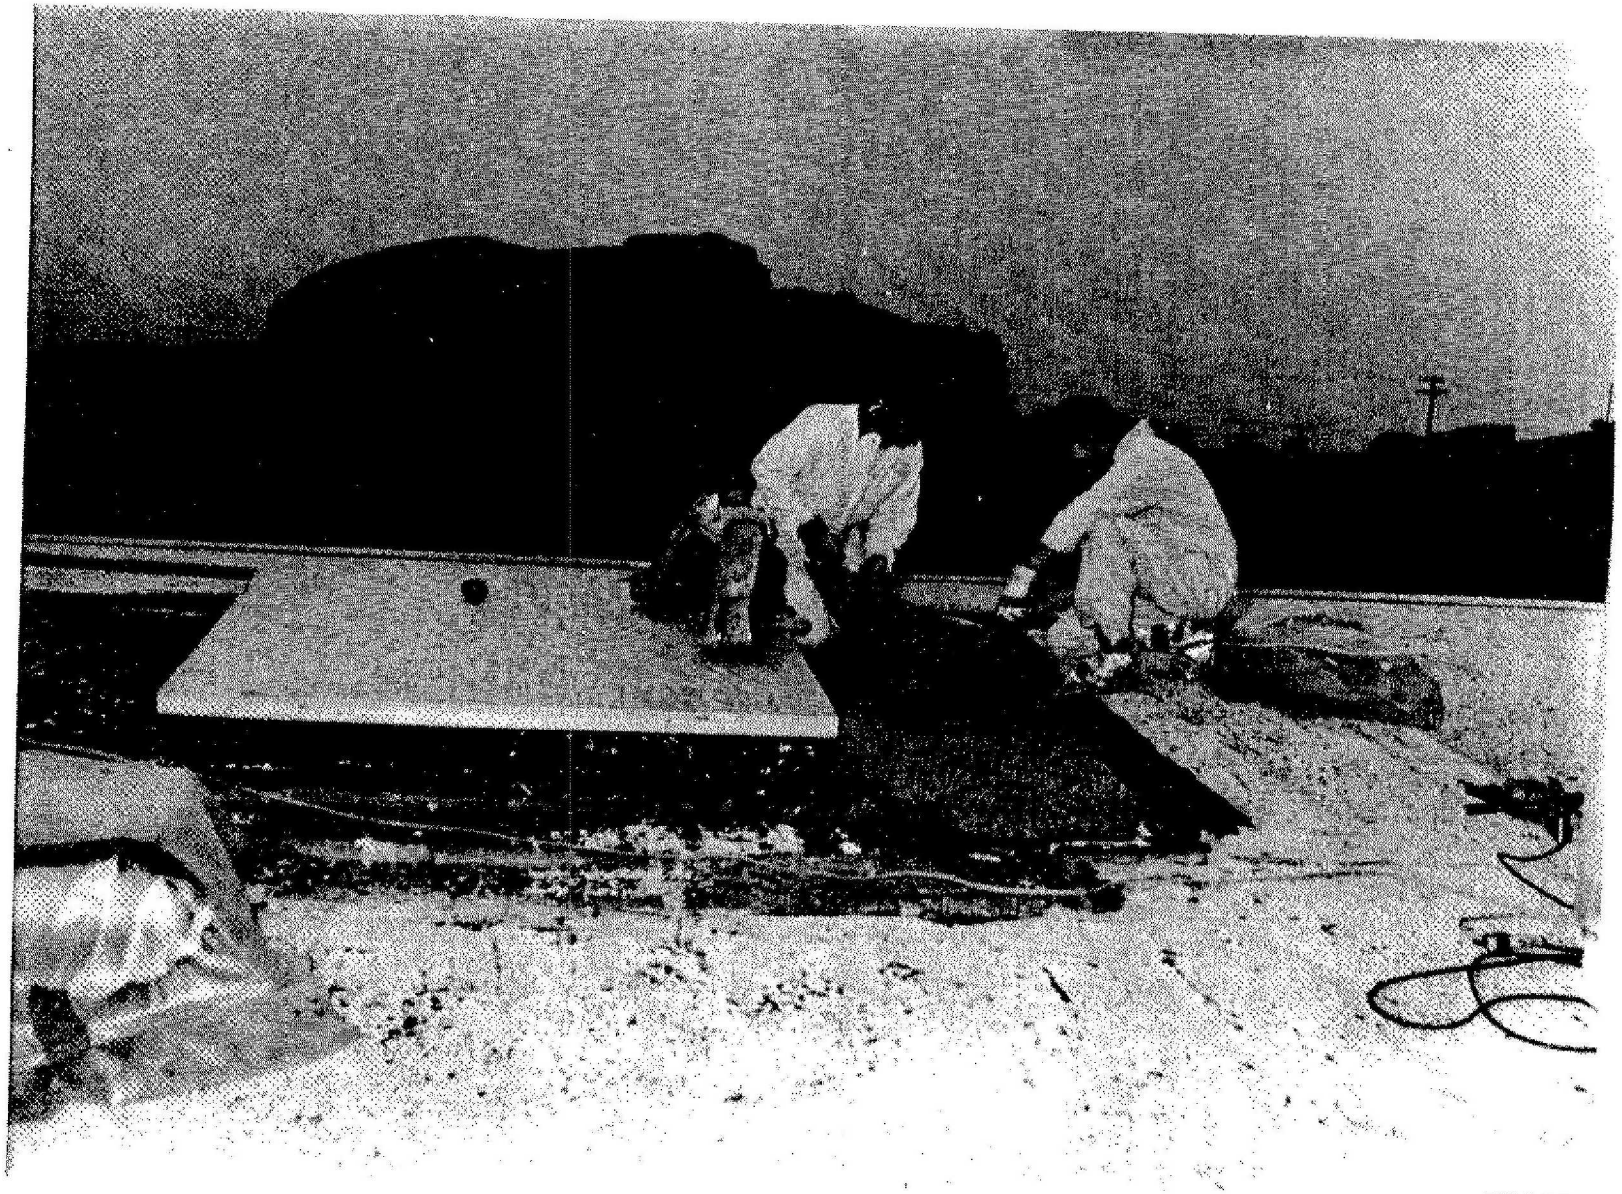
Figure 77. SRE High-Bay Roof Decontamination

The excavations were backfilled with clean soil and rubble, and the area was paved. The reactor room walls and ceiling were decontaminated by sandblasting. The SRE interior was repainted, the floor was repoured, and lighting fixtures were replaced.
